# Molly<sup>®</sup> bather<sup>®</sup> - CEN TEST REPORT

In accordance with relevant parts of draft standard EN10535:1998 Revision 1

ISSUE 1  
DATE 02/02/2001

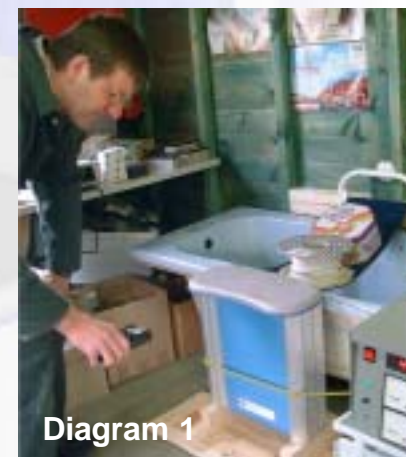
The unit was checked with an accurate sound level meter and found to comply, being 40dba, (should be <60dba). - See Diagram 1

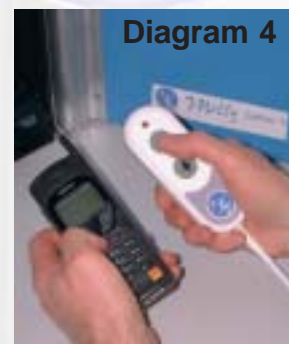
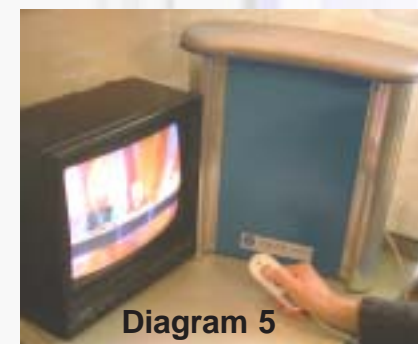
See diagrams 4 and 5 for testing, showing operation next to a Television, and a transmitting Mobile phone. Neither experienced any noticeable RFI during tests.

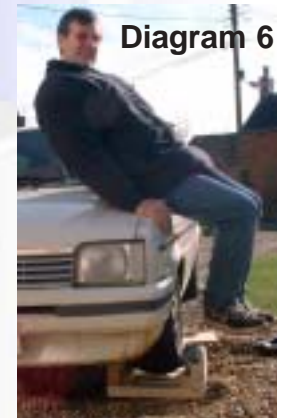
Diagram 6

Whilst there is no mandatory requirement to meet a specific level of safety factor, due to the draft CEN requirement based on an Overhead hoist with a risk of dropping a patient up to 2.5 metres, (a Belt bather which can only raise up to 0.4 metres), it was felt that a factor of  $>3$  x the maximum user weight would be sufficient to ensure the risk of a user applying additional dynamic loads in excess of the normal 'dead weight'. To ensure compliance, a section of production quality belt, together with the production fixing plates was suspended on a cradle, where a load of approximately 450kg was lowered onto it. (850kg VP Metro front off-side with 89kg person directly above belt). This ensures compliance with the standard. See diagram 6 showing belt under load.

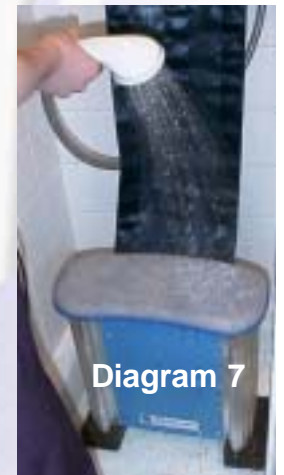
Diagram 7

To ensure exit of any water from the internal cavity of the bather, there are 5 downward facing louvres. See diagram 7 during showering the unit at all angles, which following this period the unit was left for 5 minutes prior to inspecting amount of water internally, which was only droplets. Some hours later these droplets had fully evaporated due to the through-flow design of the bather's ventilation design. This ensures compliance with the standard.

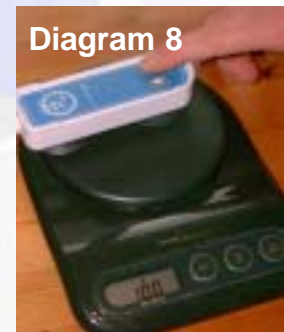
- 4.14A Operating force - finger  
The hand-control is fully waterproof and has individual silicon buttons controlling up and down functions. The overall pressure to operate the button is well below the required <5N force, (requires only 1N). This ensures CEN compliance. See diagram 8 showing method of compliance testing.

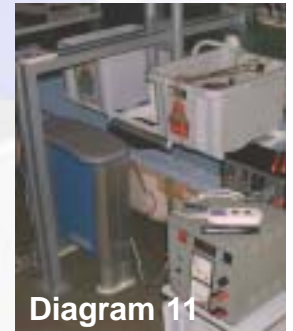
Diagram 11

- 4.18.8C Durability test 3  
Following 4.18.8B, the bather was loaded with a load of 112kg, then operated repeatedly up and down at the upper to mid end of the range. The requirement of 1000 cycles was exceeded without any fault, (achieved 1054 cycles prior to halting test). This ensures CEN compliance. See diagram 11 showing method of compliance testing.
